ARCHITECTURAL CONSERVANCY OF ONTARIO

We are pleased to present herewith an outline conservation study of the Burlington Canal Lighthouse.

Site Photos - November 2004 Site Survey

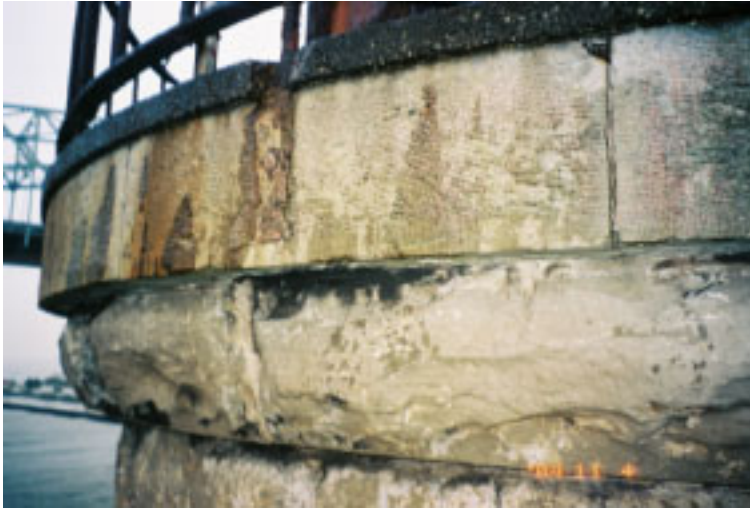
Detail of cut stone walk around lantern

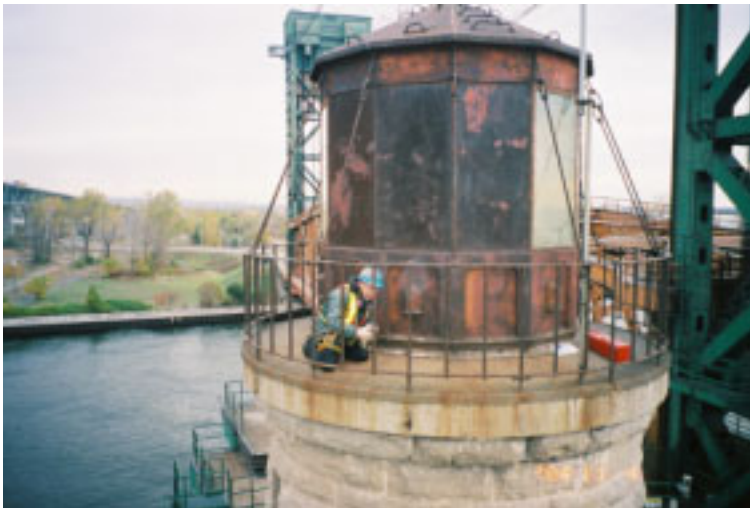
It is noted that the lantern house does not conform to images published as late as the 1870's and it is suggested that the existing may be a replacement. Early lantern houses of European manufacture typically had rounded tops. Further research is recommended.

Lantern. Dating of the lantern should be done to determine if this is the original or a change dating to the early 20th century.

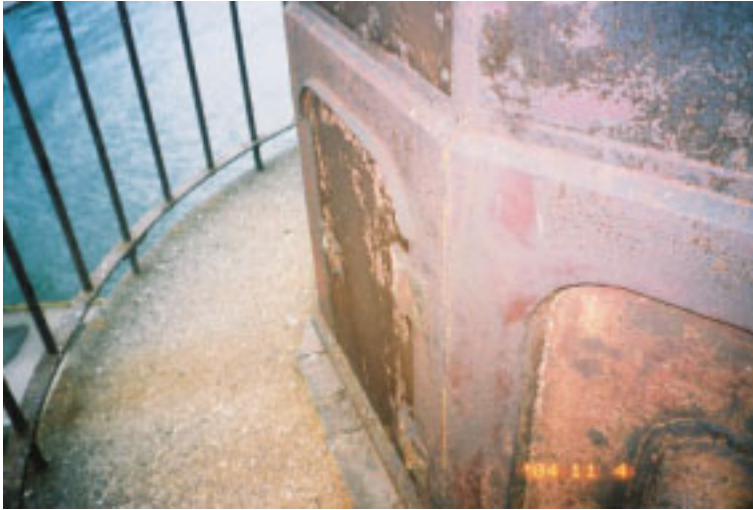
It must be noted that while the lantern is unusually complete when compared with other lighthouses in Eastern Canada, the handrail at the lantern level is not secure. Some repair to metalwork and to the supporting deck must be done to make this level safe.

Detail of catwalk

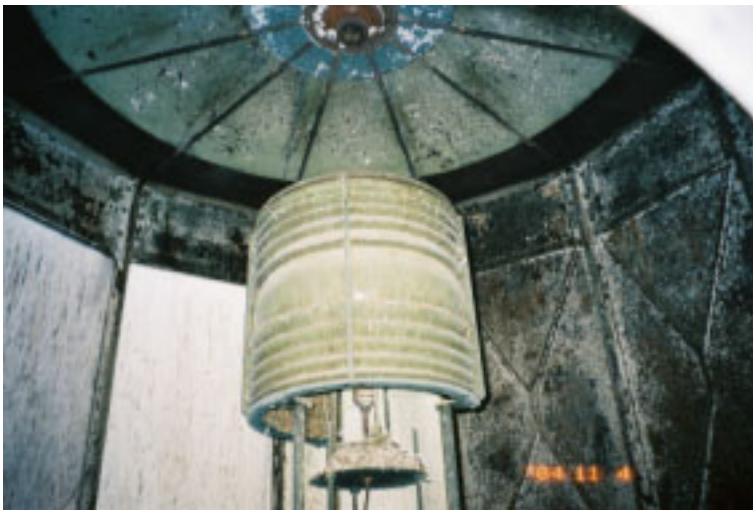
Image of last beacon mounted inside the lantern. This beacon is electric and is a mid-20th century replacement for the earlier lights

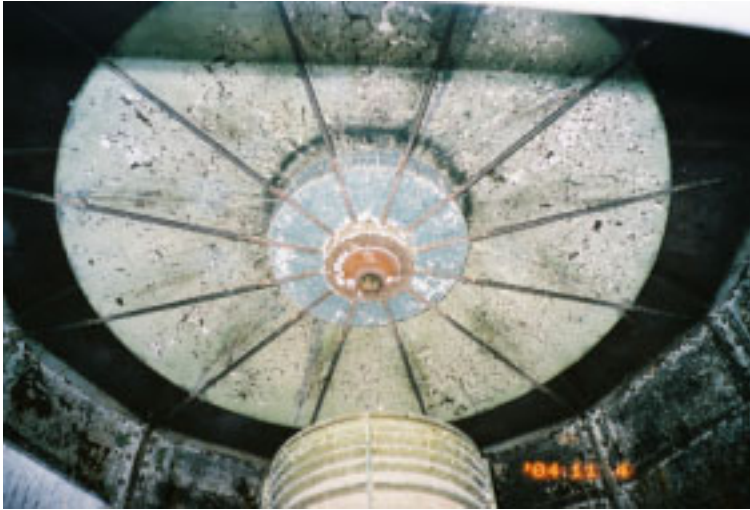
Detail of the underside of the roof of the lantern. The details suggest an early 20th century design which would have replaced an earlier 1850's assembly. Further research should be done.

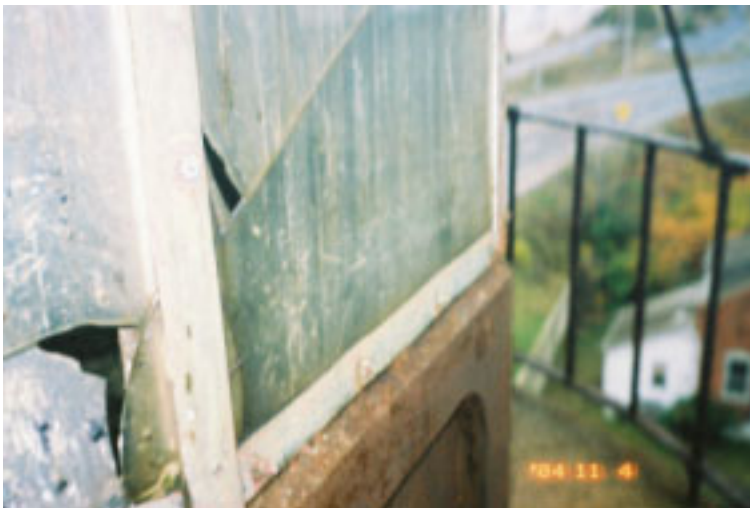
Detail of temporary repairs.

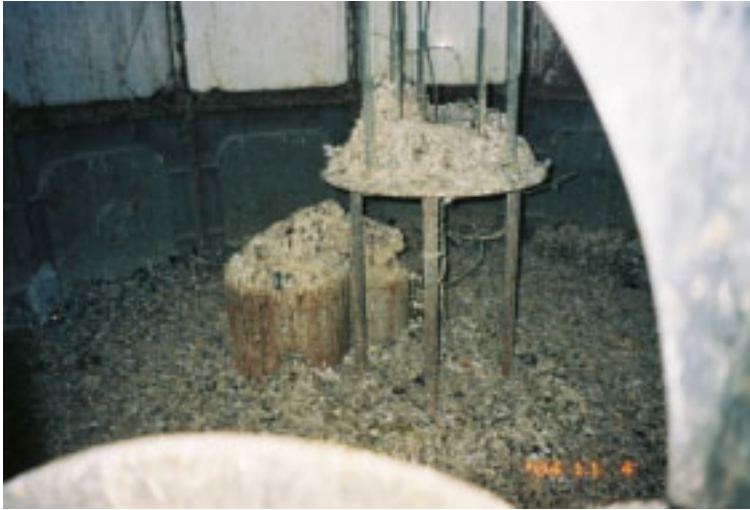
Detail of floor of lantern. Note the depth of guano on the floor. This material contains fungus and can be toxic to humans.

An environmental clean up of the pigeon guano must be done by a licensed hazardous waste contractor. After that is done, it is very important that the buildings be secured to prevent re-contamination. In addition, original coatings of lead-based paint should be removed, particularly from the lantern, and replaced with rust-stabilizing coatings (based on Tannic acid or other similar compounds).

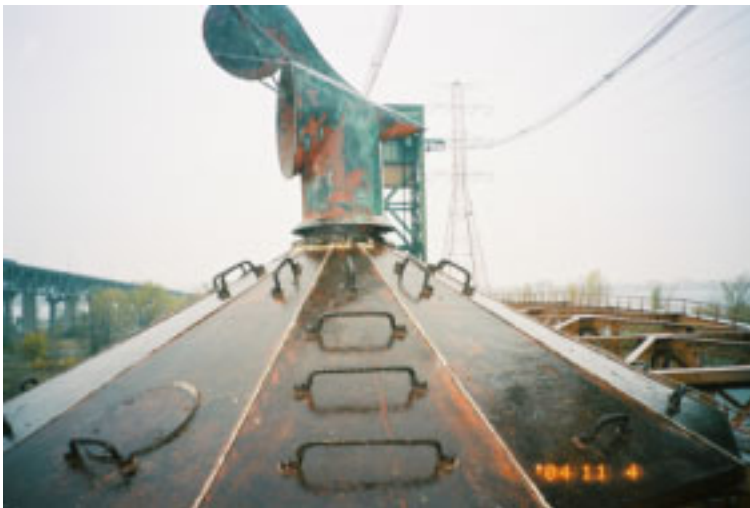
Detail of top of lantern showing ventilator with windvane which keeps the vent pointing downwind.

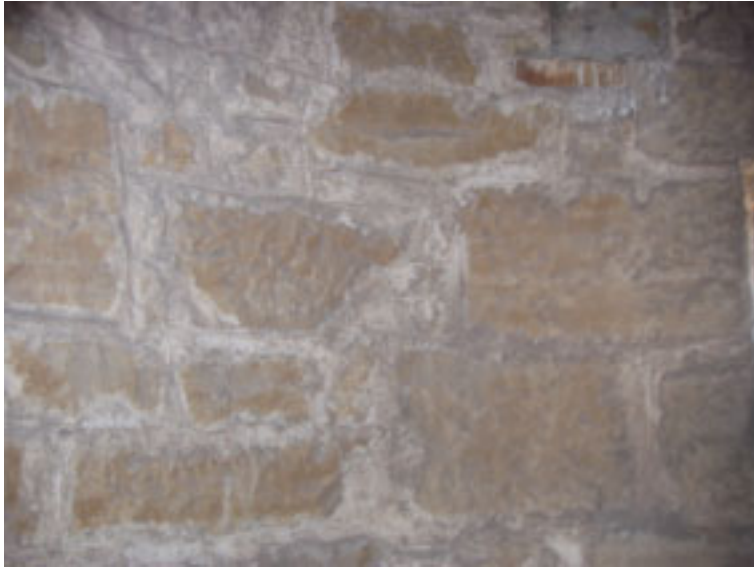
The interior surface of the masonry is in much better condition, reflecting its protected location.

Detail of stone inside tower

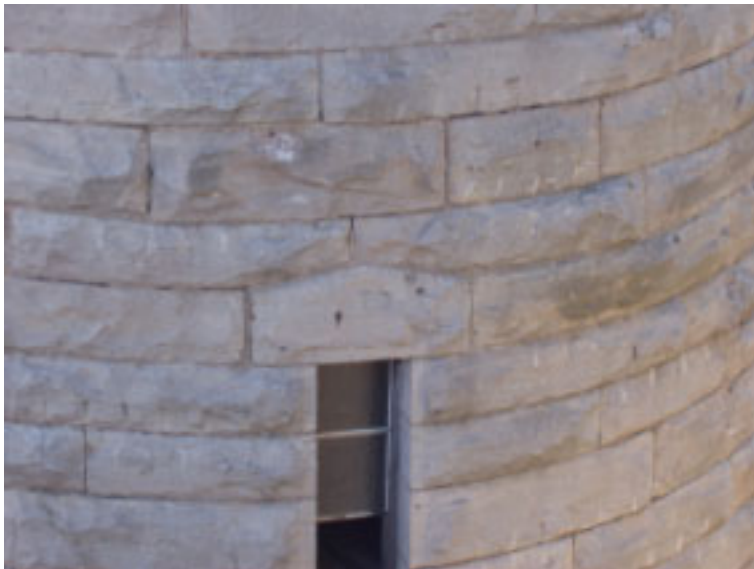
The masonry tower shaft is stable and is not showing any serious deformations and cracking. A number of masonry joints are open, particularly on the east side facing Lake Ontario. The joints have opened due to weathering, causing freeze/thaw action in the joints which eventually leads to their deterioration and failure. Thus the observation of greatest deterioration occurring toward Lake Ontario makes sense as this is where precipitation borne on the east wind off the lake occurs.

Detail of exterior of barrel of tower

Deteriorated or inadequate mortar joints must be replaced by a qualified heritage mason in accordance with good conservation practices. All loose joints made with inappropriate materials must be rebuilt. The deterioration of masonry will continue unabated in this environment. The pace of deterioration will accelerate exponentially from this point on and restoration work should proceed without delay.

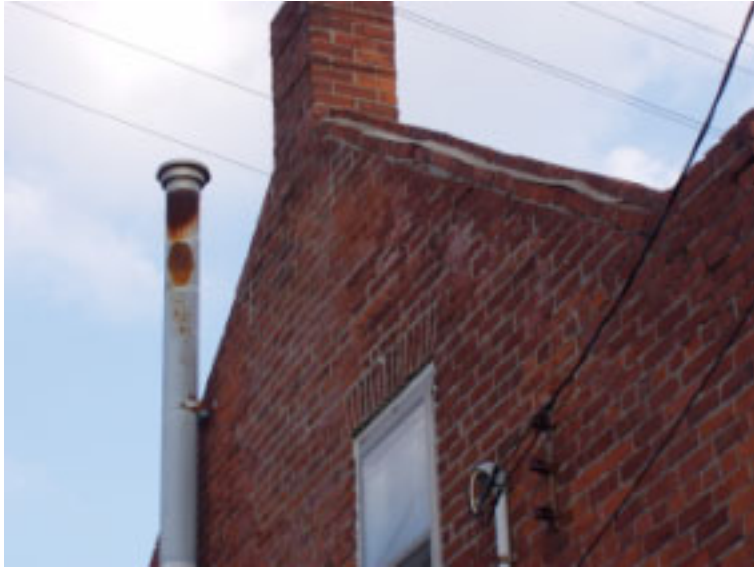
The original coping on the top of the gable walls has been removed and not replaced. This allows water to enter the middle of the brick wall. Of note are the small chimneys at the roof which sit on "shoulders" formed by the truncated remains of the original chimneys. There is sufficient photographic and in situ information to permit a complete restoration of these elements.

There are signs of water infiltration into the building at the gable ends of the second floor ceiling as evidenced by failing plaster. This may be due to the lack of copings on the gable walls.

Gable wall – note the absence of a cap on the parapet and the small masonry chimney

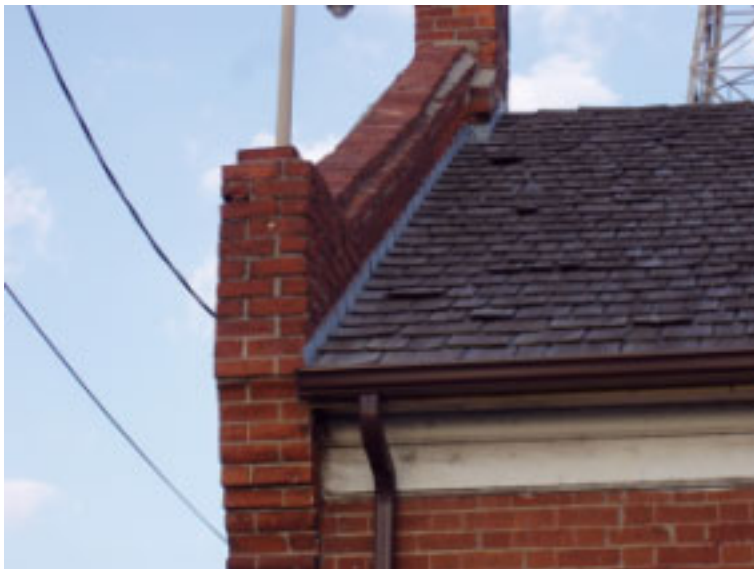
A prime feature of the original house would have been the chimneys which are currently too small in relation to the original. However, the bases of the original chimneys are clearly visible on the peak of each gable forming a “shoulder” under the current units. Using this evidence and early photographs, an entirely appropriate restoration is possible.

Detail of north gable. Note the shoulder under the chimney which is the base of the original chimney.
